## **New Generation Features**

Rubber Tracks for Excavators

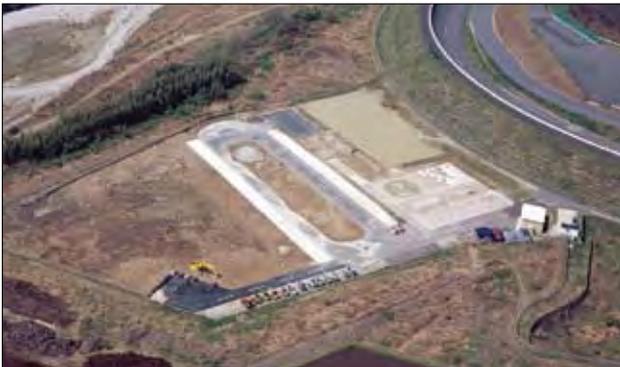
## Bridgestone Proving Ground

Bridgestone's state-of-the-art Rubber Track proving ground, located in Tochigi-Japan, ensures the highest integrity designs for Rubber Tracks and undercarriage systems. A variety of terrain conditions are maintained in order to establish consistency during the testing process.

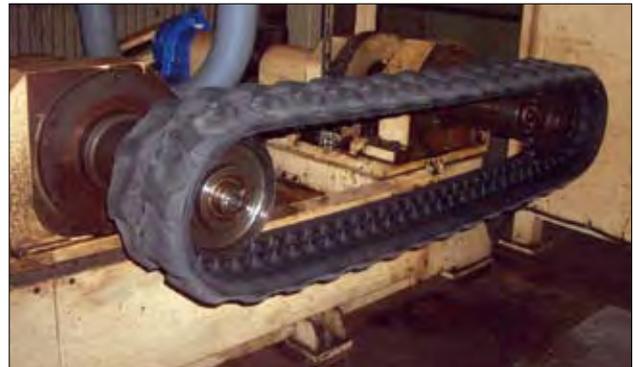
## Laboratory Bench Testing

Laboratory bench testing is vital to accelerate evaluation under controlled conditions. All Bridgestone Rubber Tracks are tested, evaluated, and proved.

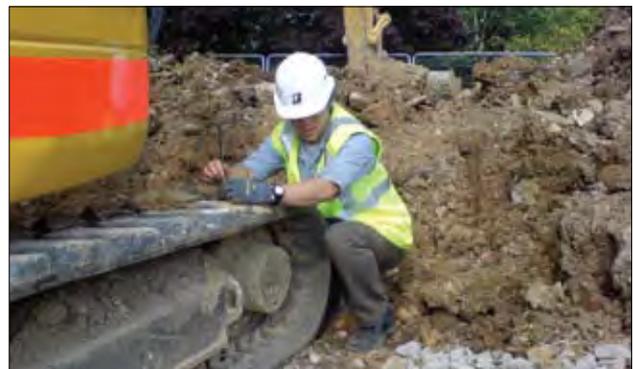
## Product and Technical Assistance

Bridgestone evaluates in real-life environments and proves products by using actual machines in actual field conditions throughout the world for all Rubber Track applications.

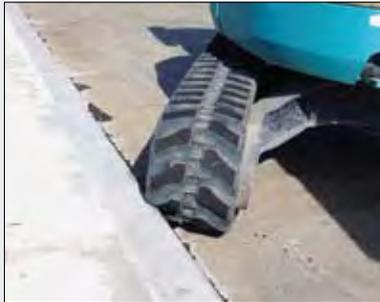
Edge-cut is a common type of damage for tracks used on construction sites. When a machine drives against a curb, stump or sharp/solid object, the edge of the track can bend over, shearing the rubber between the edge of the track and the tip of the embedded core metal.

Common cause of edge-cut

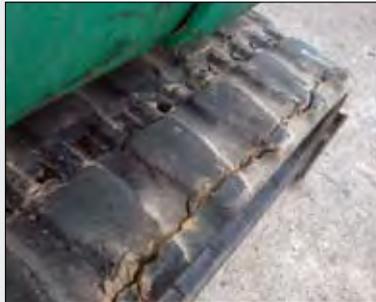
After 1000 hours

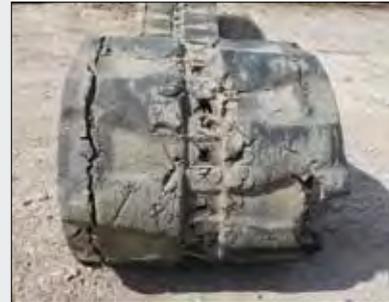
After 1900 hours

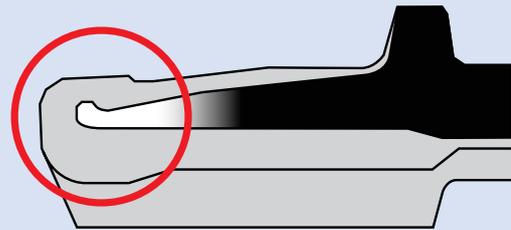
Bridgestone developed innovative Pro-Edge technology to minimize edge-cut damage. Pro-Edge technology is based on the combination of a rounded shape core metal edge design to avoid the build-up of stress concentrations, and additional rubber volume on both the inner and tread sides to make the track edge more durable.

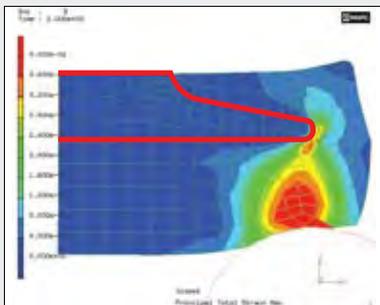
Standard core metal

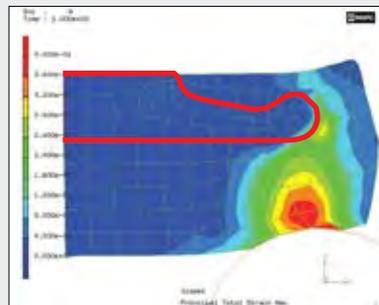
Pro-Edge core metal  
47% less stress on the core metal edge compared to a standard core metal.

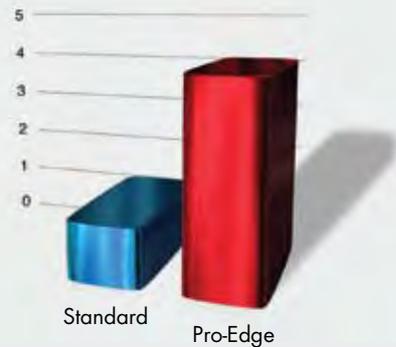
Pro-Edge 4-fold improvement  
300mm width track testing data on 3.5ton machine. Graph shows the number of trials made before edge cut occurred.

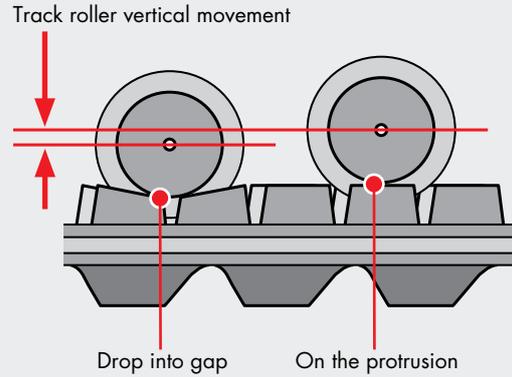
Good ride comfort is of vital importance to the health and safety of machine operators. Low vibration is a key factor considered when selecting a machine and a rubber track. Some vibration is caused by the vertical movement of track rollers when dropping into the gaps between each core metal protrusion.

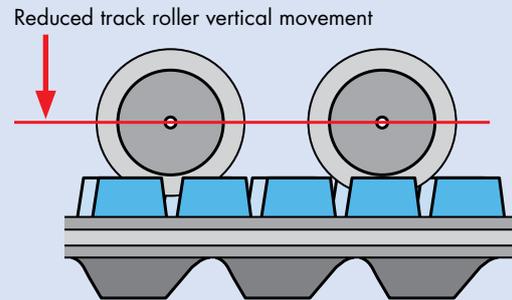
Bridgestone has reduced the vertical movement of the track rollers by adopting an advanced tapered protrusion technology. The tapered shape of the running surface of the protrusion optimizes the roller path against the natural rotation of the core metal under vertical load. This results in good ride comfort without the need of additional material. Avoiding the use of additional material is in line with Bridgestone's environmental policy.

FEM analysis result: Track roller vertical movement

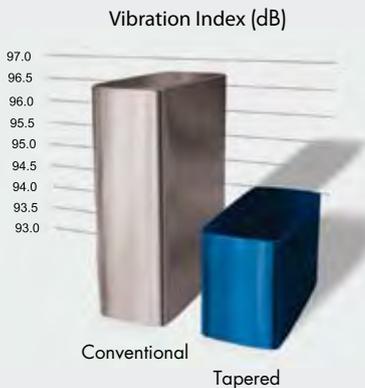
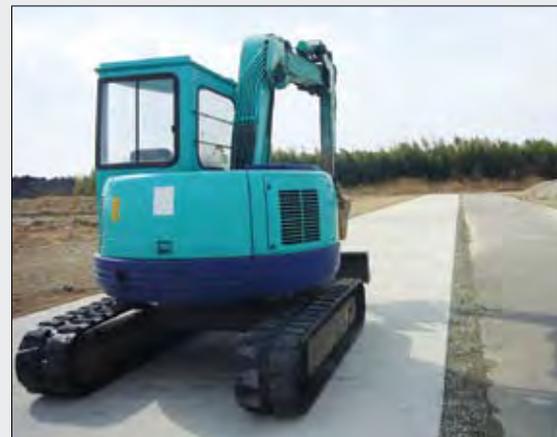
Data obtained by FEM analysis and field testing clearly shows a reduction in vibration using tapered core metals. This brings greater ride comfort to the operator.

Testing carried out at Bridgestone's proving ground in Tochigi Japan using 5.3ton machine on asphalt.

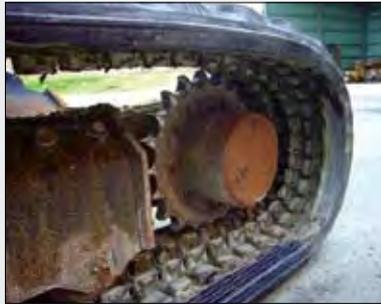
De-tracking at sprocket

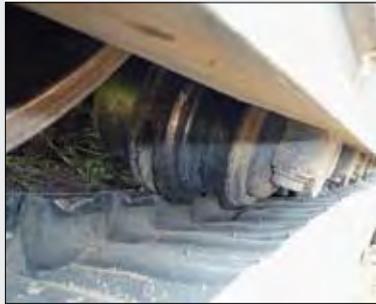
De-tracking at track roller

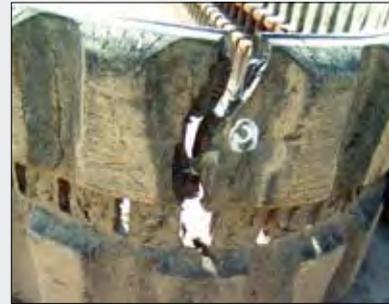
Steel cord breakage caused by de-tracking

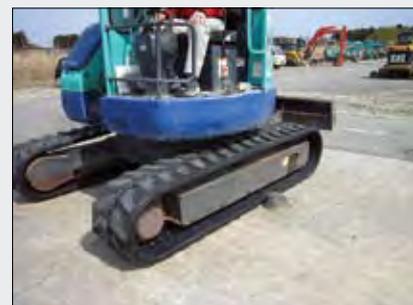
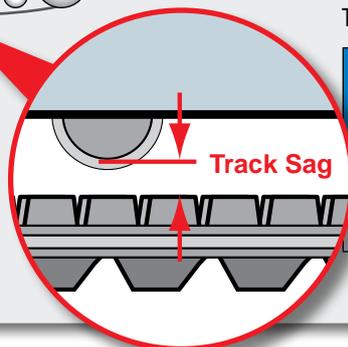
The following testing was carried out at Bridgestone's proving ground in Tochigi Japan. Even in loose tension conditions (sag=45mm) interlocking tracks did not de-track.

Test data from 5.3ton machine, 10 trials against fixed rock.

Tension	Track sag	De-tracking occurrence	
		Interlocking	Non-Interlocking
Normal	15mm	Zero	6
Loose	30mm	Zero	10
Very Loose	45mm	Zero	10

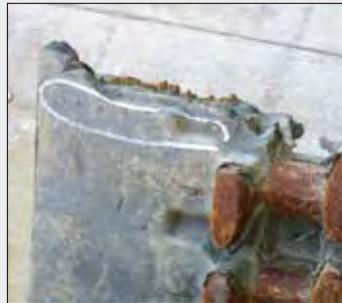
The majority of Rubber Tracks utilize a traditional overlap type structure of steel cord. When the track is under abnormal stress such as excessive tension, failure often occurs at the ends of the overlap area. This is expected due to the inferior uniformity in the circumferential steel cord structure.

Steel cord breakage at end of overlap

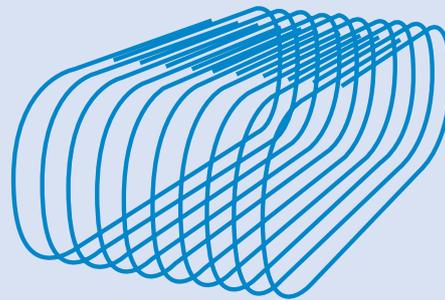
Overlap joint structure

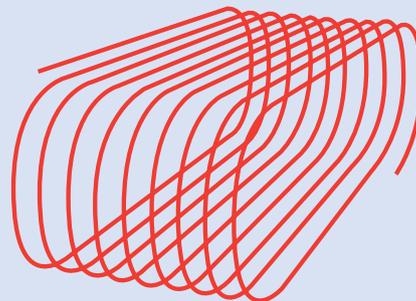
Bridgestone has developed a spiral steel cord structure which is now a technology commonly used in Bridgestone tracks used on Compact Track Loaders. This technology is now being expanded into excavator tracks. Spiral steel cord technology offers complete uniformity of tensile strength around the circumference of the track. In addition to even tension, an even distribution of traction minimizes the risk of track breakage.

Spiral structure

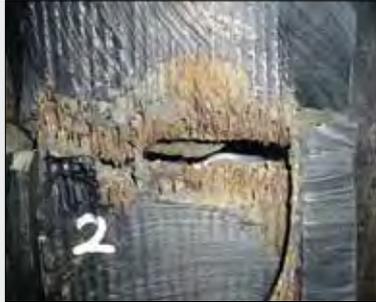
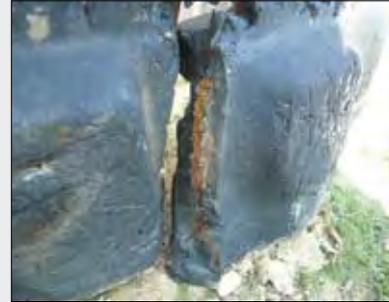
Once deep external cuts, chunking and edge cut have occurred, the danger of water and mud penetrating the rubber track is greatly increased. Moisture attacks the embedded steel cord. Depending on the severity of the damage and working conditions, the tensile strength of rusted steel cords weakens and can lead to breakage.

Steel cord deterioration caused by rust

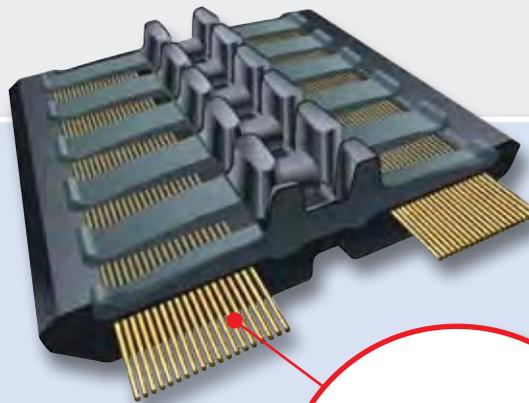
Thanks to Bridgestone's world leading tire technology, our engineers have developed an advanced Anti-Rust Steel cord which minimizes deterioration caused by rust.

Even when moisture/mud penetrates from external cuts, steel cord tensile strength is maintained for longer.

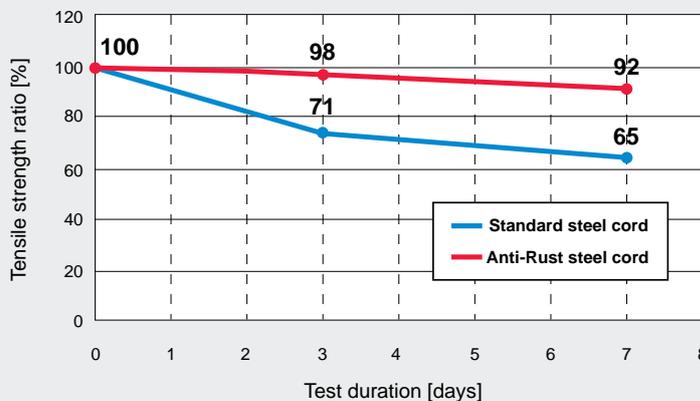
Salt bath testing carried out over 7 days has proved over 41% improvement in performance compared with standard steel cord.

Anti-Rust Steel cord deterioration performance

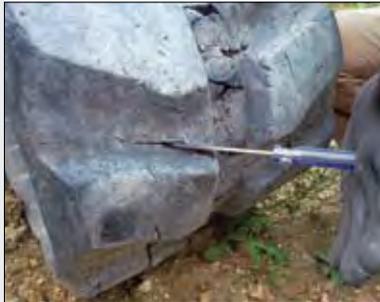
External cut

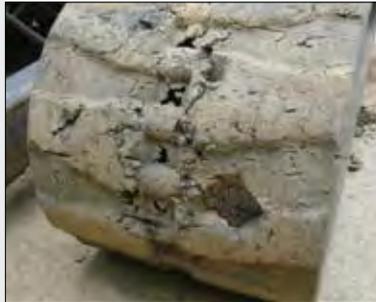
Rubber chunking

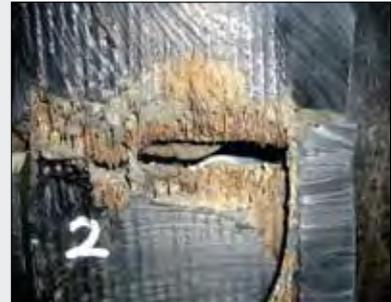
Steel cord breakage caused by rust

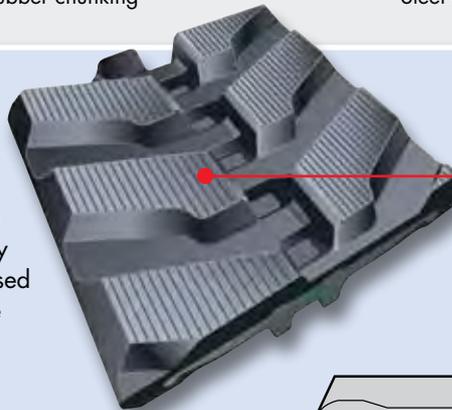
Tread side is made of an Anti-Cut Rubber compound.

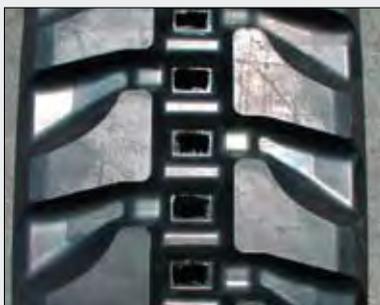
Test data shows reduced occurrences of cut damage and chunking. The photos below compare the track condition after 140hrs of continuous tracking using a 3.5ton machine at Bridgestone's proving ground.

Before testing

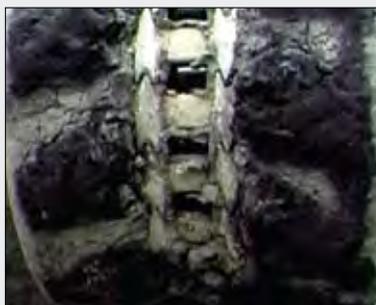
Conventional rubber compound

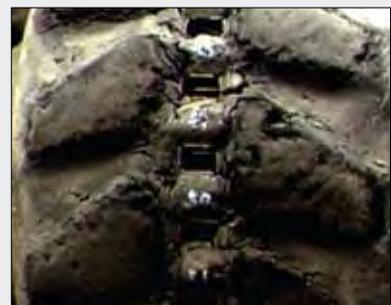
Bridgestone Anti-Cut rubber compound

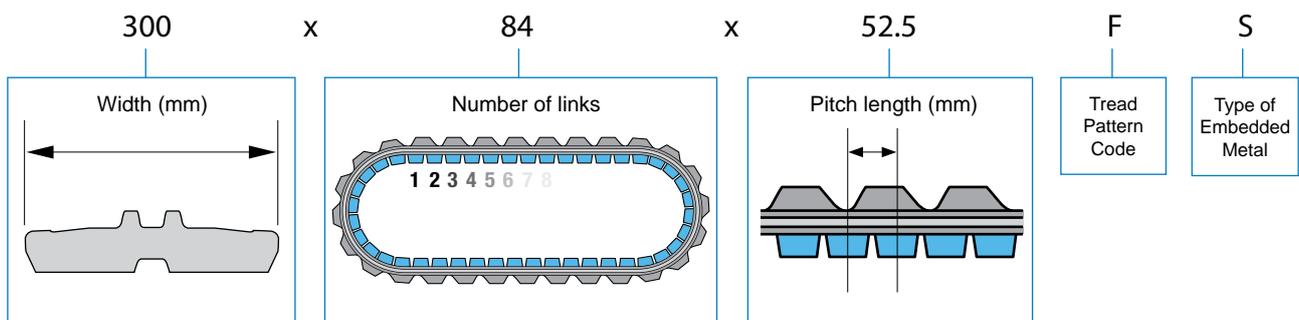
Track size is indicated by a size numbering system consisting of 5 elements. This part number is normally vulcanized on the inner surface of the track.
